PROPERTY INSPECTION REPORT

Concerning: **24175 Sample Ave., Detroit, MI**

Inspection Date: **November 30, 2013**

Construction: **Metal frame office building on a concrete slab foundation**

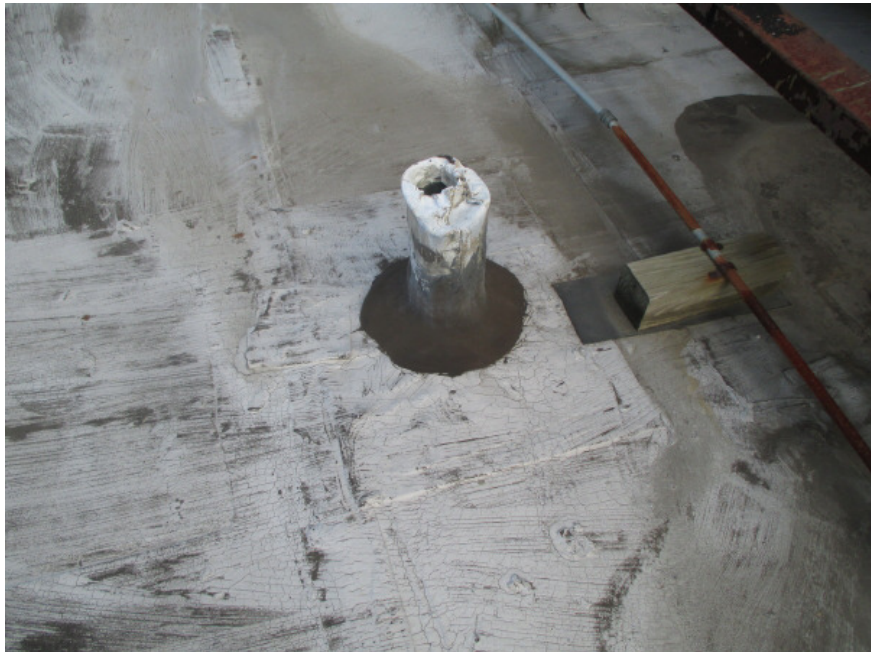
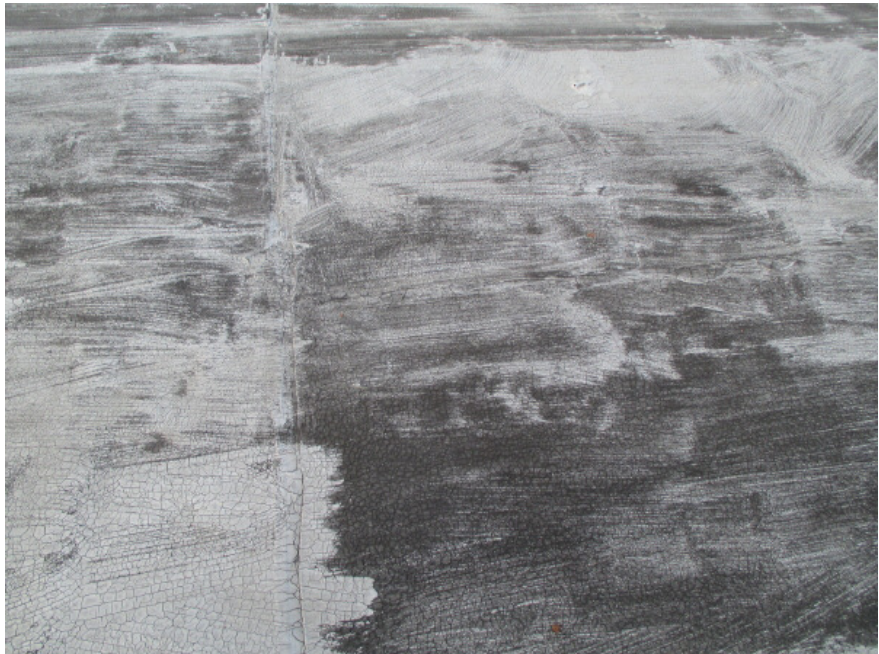
- "Alligatoring" of flat roof; not very severe: Noticeable "alligatoring" (cracking) of the roof surface was observed, indicating deterioration of the surface, though the cracking was still rather fine, for the most part, with no deep cracking observed of the type which would indicate the need for immediate resurfacing. Top-coating after cleaning off dirt and debris every few years can help preserve the surface, but there are limits to its effectiveness. When the top-coating can no longer control the cracking and/or bubbling (delamination) of the surface appears, the surface will need repair and eventual replacement. Built-up roofing can only be covered over a few times before the weight is excessive, and the entire roof needs to be removed, which is a very difficult and expensive process. Modern membrane materials for flat roofs tend to be more durable and easily replaced.

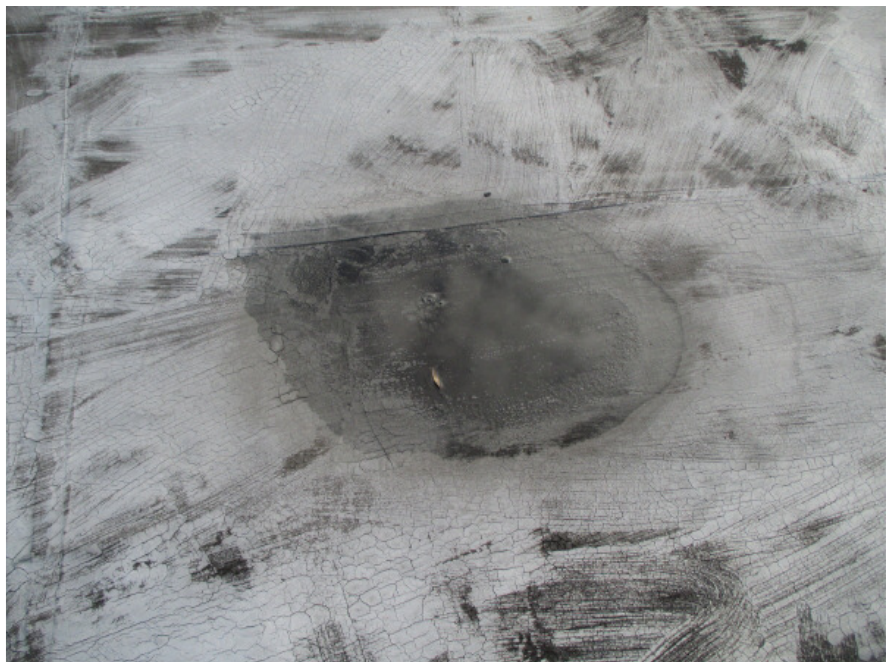
- Some folds and slight depressions in which water and debris tended to pool were observed on the roof surface.

Folds are a feature of substandard installation, and tend to crack and deteriorate more rapidly than a properly installed surface, but a few isolated folds, such as observed on this roof, are difficult to avoid during installation, and typical.

Depressions are typically artifacts of a substandard configuration that did not provide for proper drainage, and can also cause premature deterioration. Typically if water in such depressions evaporates within about 2 days under dry conditions, as appeared likely on this roof, such shallow depressions are unlikely to have a great impact on the life span of the surface, but debris can render top-coating ineffective if not cleaned off.

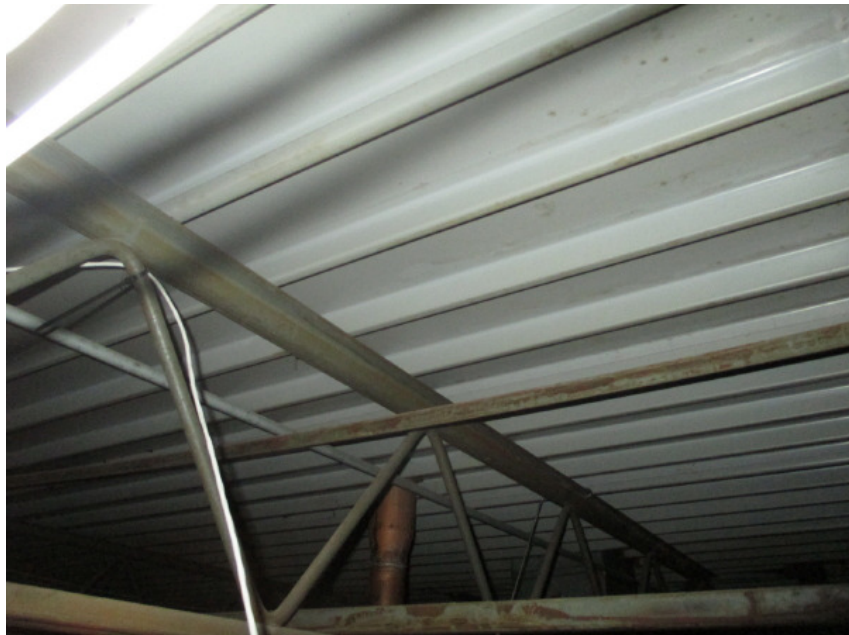
- Limitations: Roof structure was viewed from a few vantage points where the drop ceiling tiles were lifted due to time constraints. These were chosen on the basis of accessibility, quality of view, and exterior roof observations.
- Metal framing, ceiling structure, and corrugated metal roof sheathing were generally in good condition where visible.

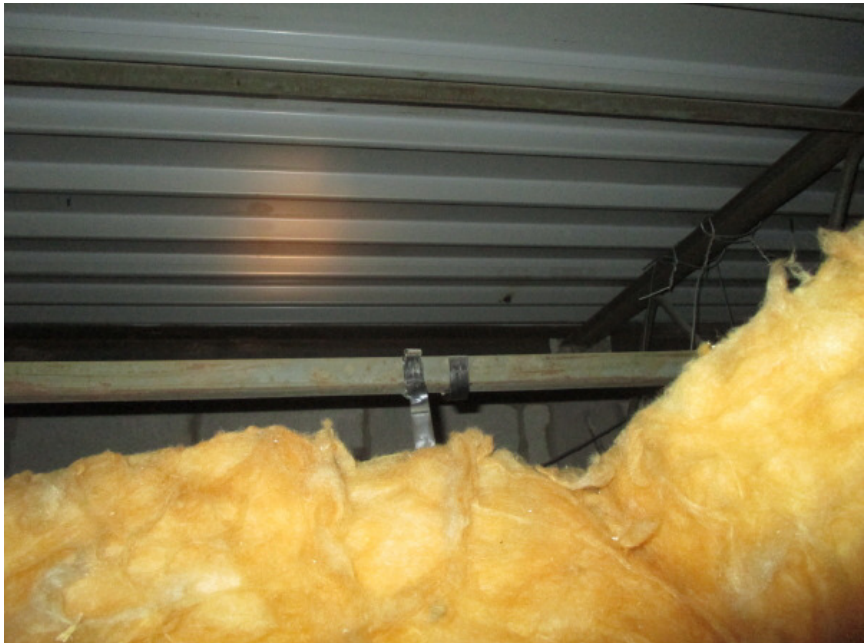
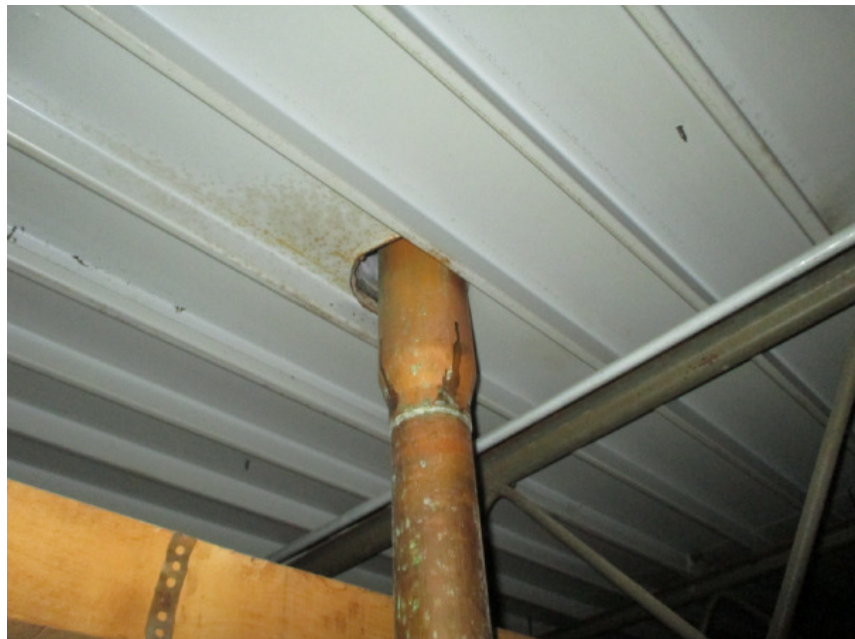
Plumbing stack/vent pipe

- Rolled insulation was observed above the drop ceiling in one of the offices. Requirements for accessibility to structural and mechanical features limited the ability to effectively insulate the upper level ceilings, aside from using ceiling tiles that provide maximum insulation for their configuration.

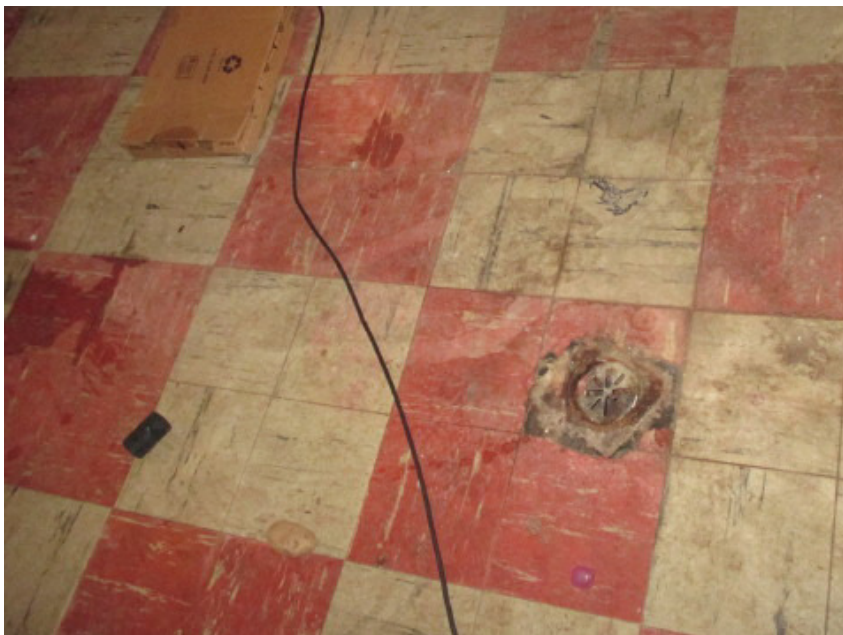
- Ceilings and floors were observed to be in good overall condition, and free of significant defects or structural issues at the time of the inspection, except for noted possible concerns.
- Old floor tile was observed in utility rooms. The small tile pieces appeared to be of a variety that often contained asbestos. The tile was observed to be generally in good condition.

Asbestos dust can be hazardous. Such tiles generally do not pose a hazard if the floors are kept clean and the pieces are intact.

If the tile is removed it is important to use proper asbestos removal precautions. Building codes may prohibit covering of asbestos tile to avoid concealing hazards that may result if material is later removed.

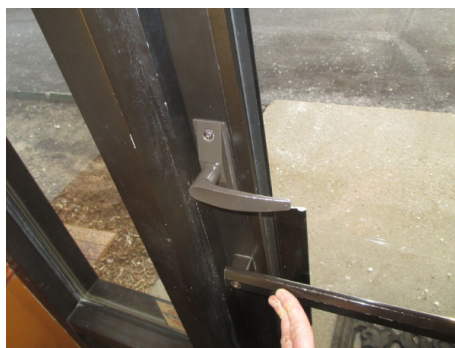
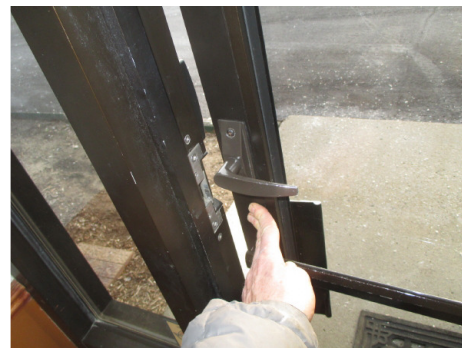
- Security Issue: Entry door on the main parking lot (SW) side did not latch properly, such that it could be pushed or pulled open even when locked. Lock/latch hardware was evidently out of alignment.

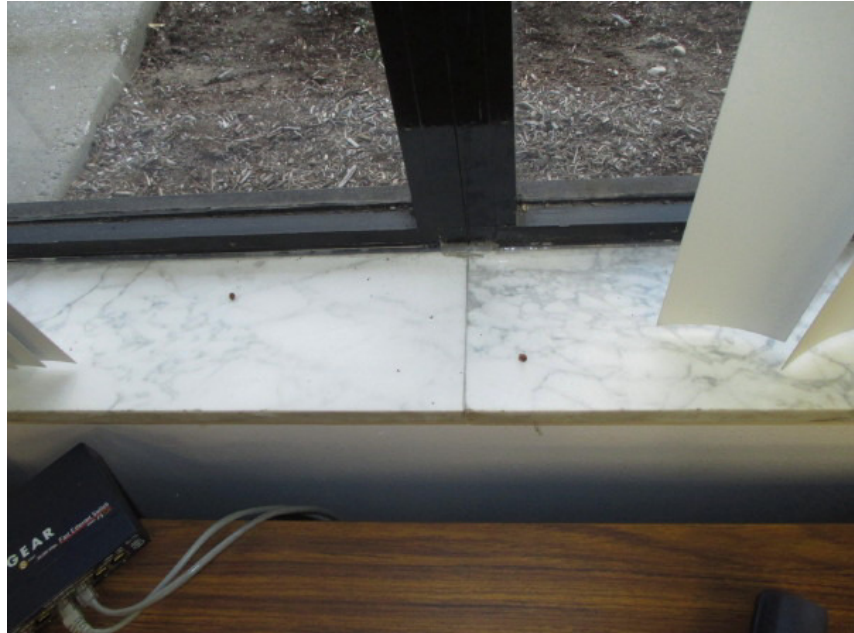
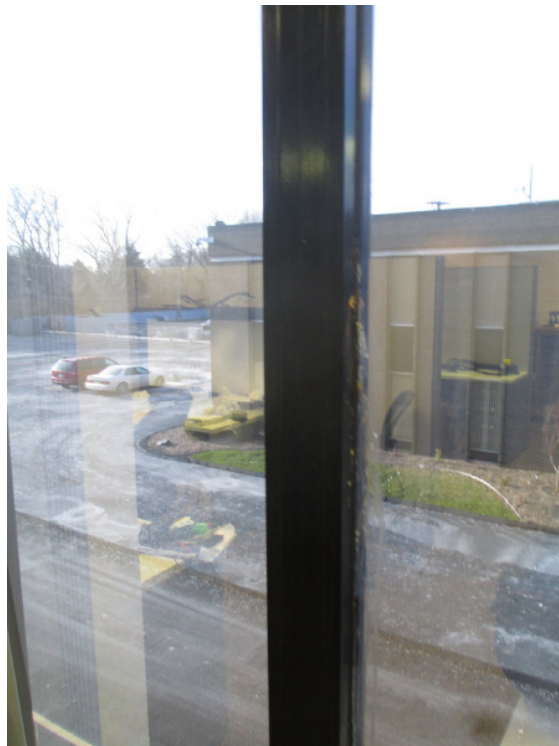
- Some window caulking was deteriorated. This may allow leakage through the windows. Some insects were observed near the windows in the 1st floor office near the W corner and indications of possible leakage were observed on a window near the center of the NW side.

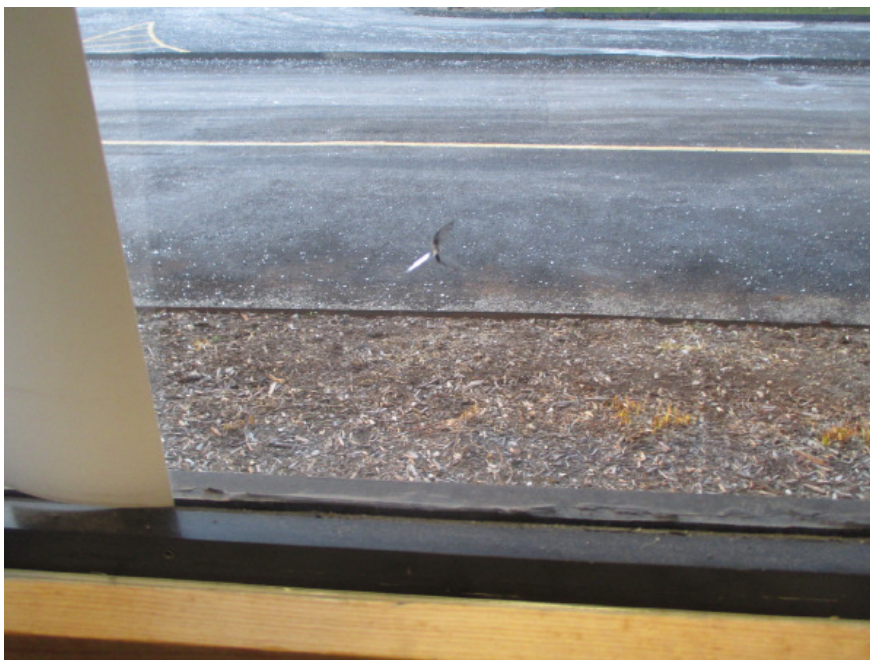
- A small crack that was evidently from a pebble or some other small object was observed on a 1st floor window near the center of the NW (exit driveway) side. This was evidently essentially cosmetic in effect.

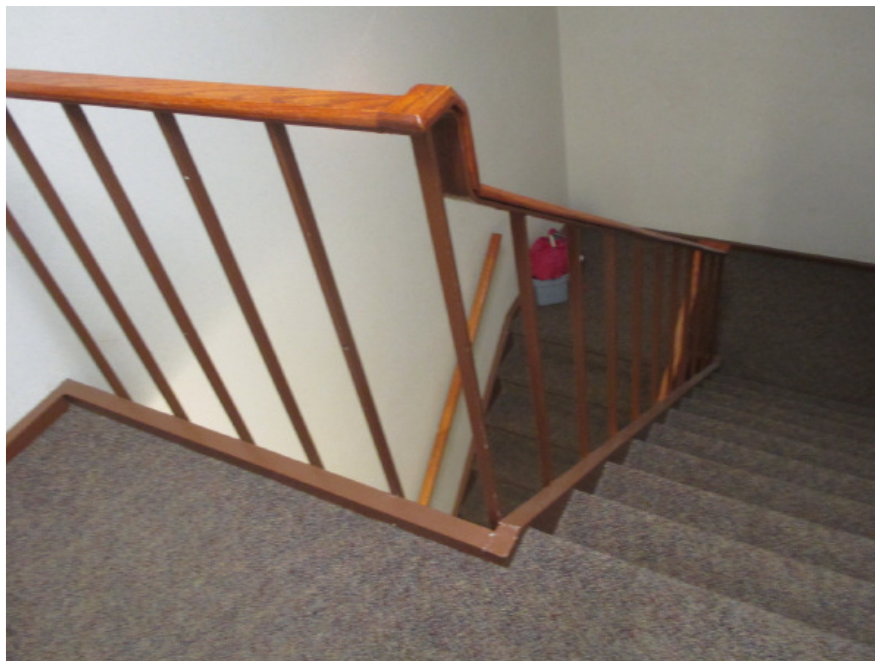
- Stairways had improperly configured guard rails, with too wide of spaces. Guard rails with no openings exceeding 4" in width into which small children could fall or get stuck are recommended on open sides of all stairways exceeding 2 steps or 30 inches. Such standards evidently had not been in effect at the time of construction.

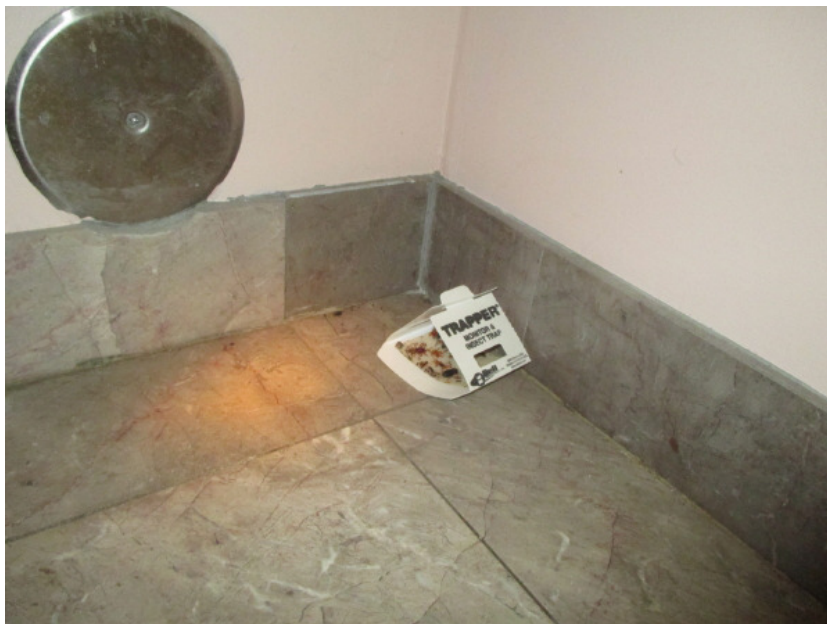
- Parking lot, and other paved surfaces were observed to be generally serviceable and in good condition, with no significant issues observed.
- Some insect traps were observed. There were not an exceptional number of insects in the traps, in general.

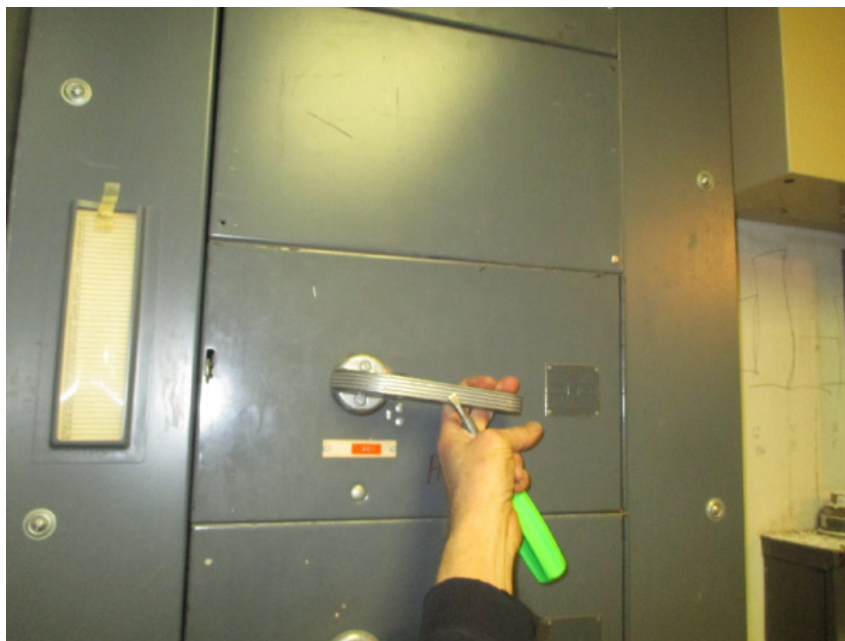
- Old panel to the L of the main switch in the 1st floor electrical utility room tested as having no power, and its terminals were noticeably corroded. Evidently all its wiring was disconnected, no longer in use.
 - Circuits in panel LPE on the 2nd floor numbered 18 & 20 (labeled for the disconnected sign noted below) and 28 & 30 (labeled for a pump, possibly for the boiler that had been removed) were evidently deliberately turned off (marked with dots).
- Many other circuit breakers had no circuits connected to them, and were tripped off by Inspector to mark them as such.

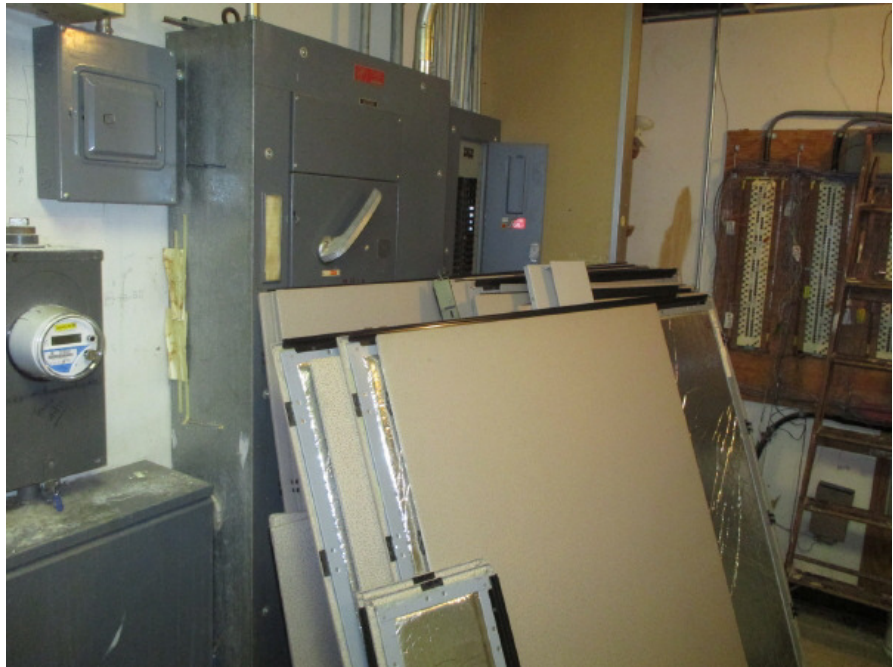
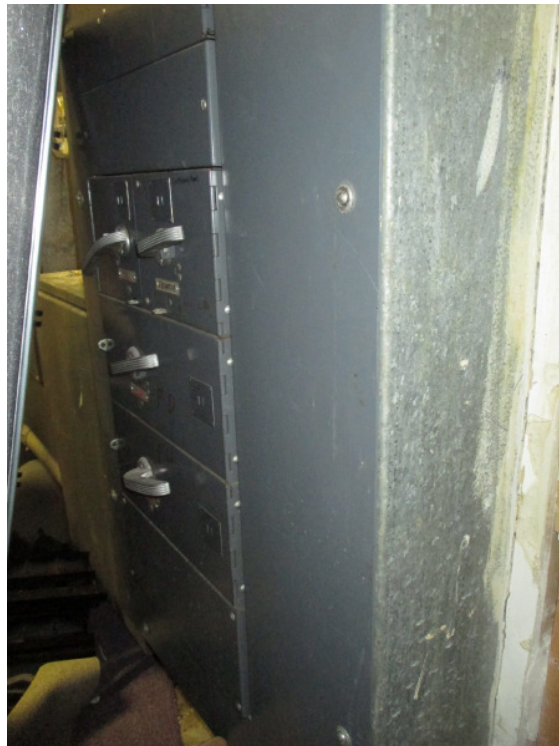
- Safety issue: Main service disconnect switch for the building, distribution panel PD, and several other panel or equipment disconnect switches in the 1st floor electrical room were obstructed by heavy cubicle panel boards that were improperly stored. It is very important that all active distribution panels be accessible to turn off power in an emergency.

- Noticeable corrosion was observed on LPE circuit #30, which was turned off and not in use anyway.

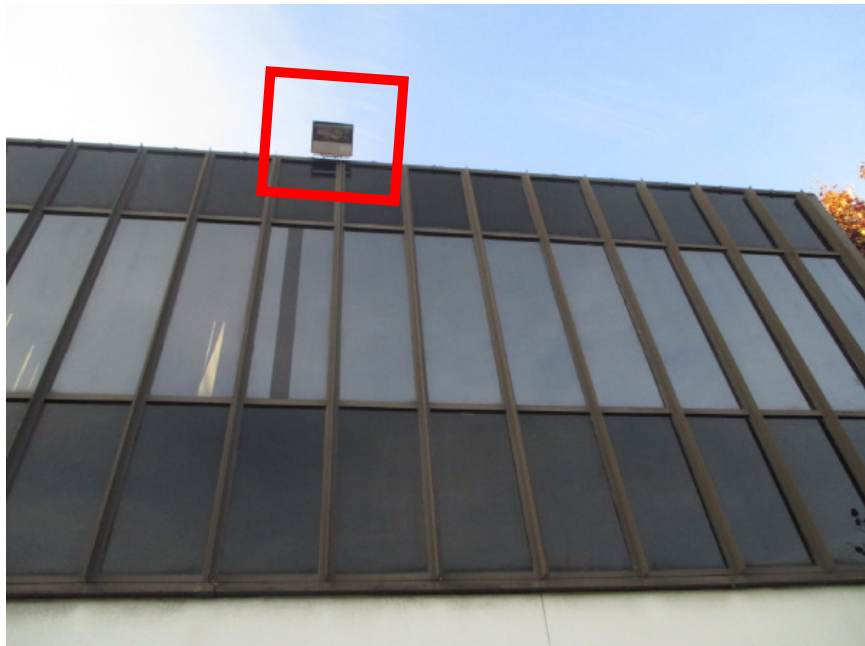
- Security issue: One of the exterior lights on the edge of the roof was misdirected, pointing upward, rather than at the main parking lot; and did not turn on when it got dark. Another of the lights on the SE edge of the roof was also out. These light fixtures possibly had burned-out bulbs.

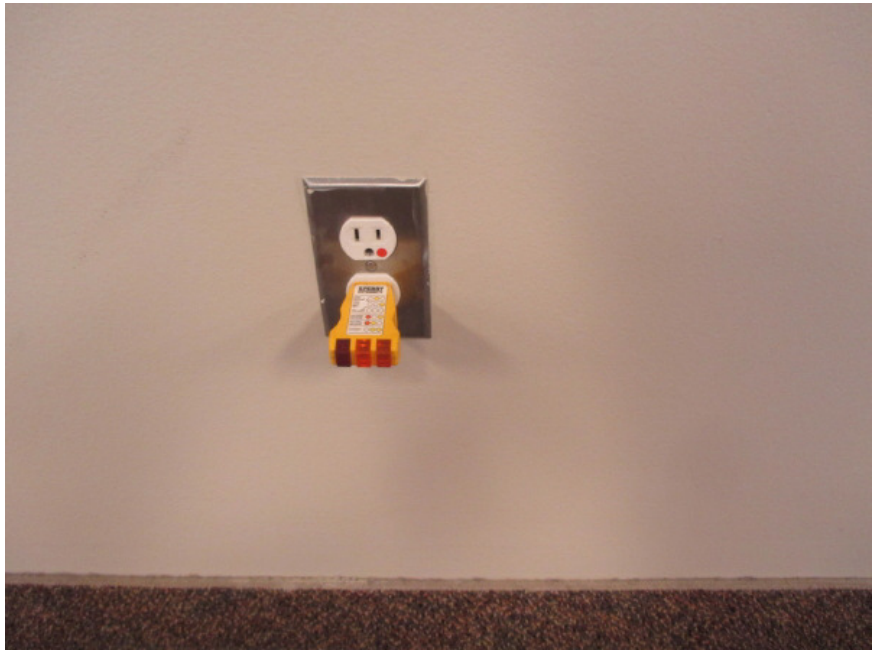
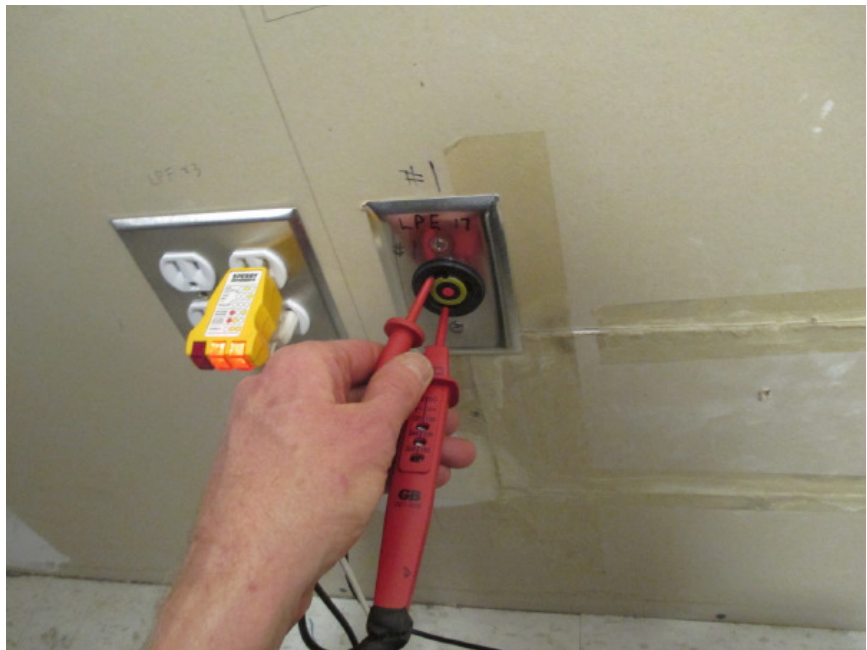
- Outlet in the 2nd floor SE hallway and some of the outlets configured for circular blades (such as one labeled for the disused circuit LPE 17) did not function. Wiring for the latter most likely had been disconnected, the outlets possibly having been used for obsolete equipment no longer in service. The outlet in the 2nd floor computer equipment room labeled for LPE 40 tested as having 120V functionality.

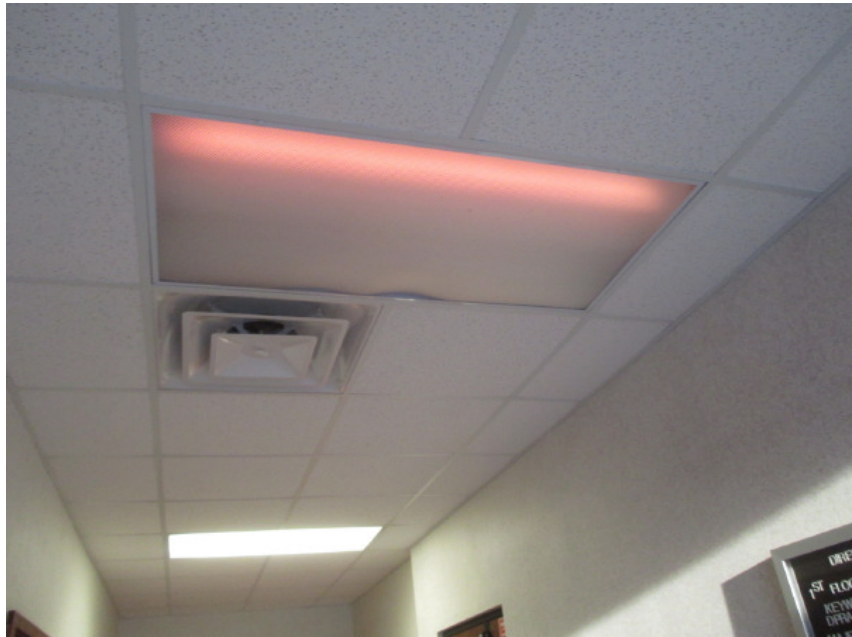
- Some fluorescent light fixtures did not turn on, or had dim bulbs. It is possible bulbs were missing or burned out where the fixtures did not operate. Dim bulbs can damage fluorescent light fixtures. If the lights do not operate with new bulbs the fixture, switch, or wiring may be faulty.

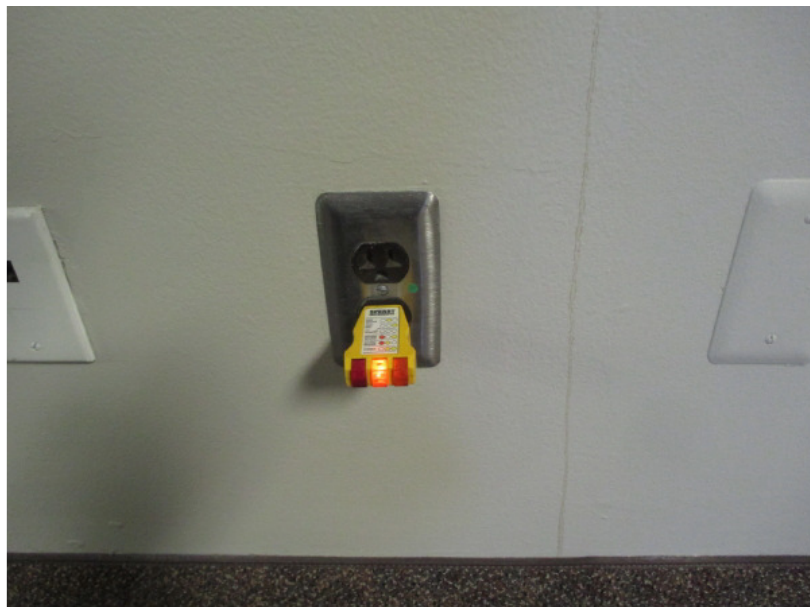
- A few outlets tested as having an open ground (marked with green dots) or poor grounding connection, evidently due to worn, dirty, and/or excessively tarnished terminals (marked with yellow dots). Replacement of such outlets is recommended, as effective grounding provides a measure of protection against equipment damage or electric shock.

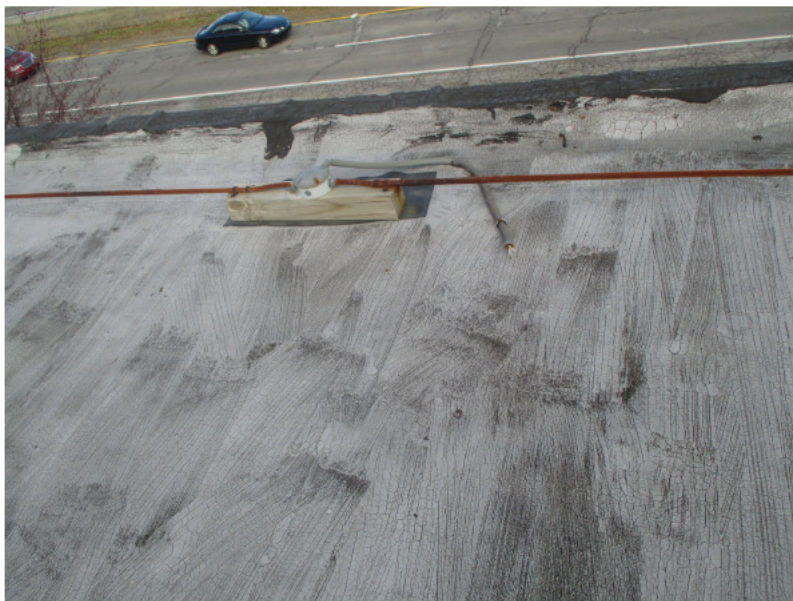
- Disconnected wiring was observed on the roof, reportedly for a sign that had been taken down. Power to the wiring had been turned off, but the wiring was no enclosed. Enclosure of the wiring is recommended to protect it from corrosion so it could be usable if desired by a later lessee.

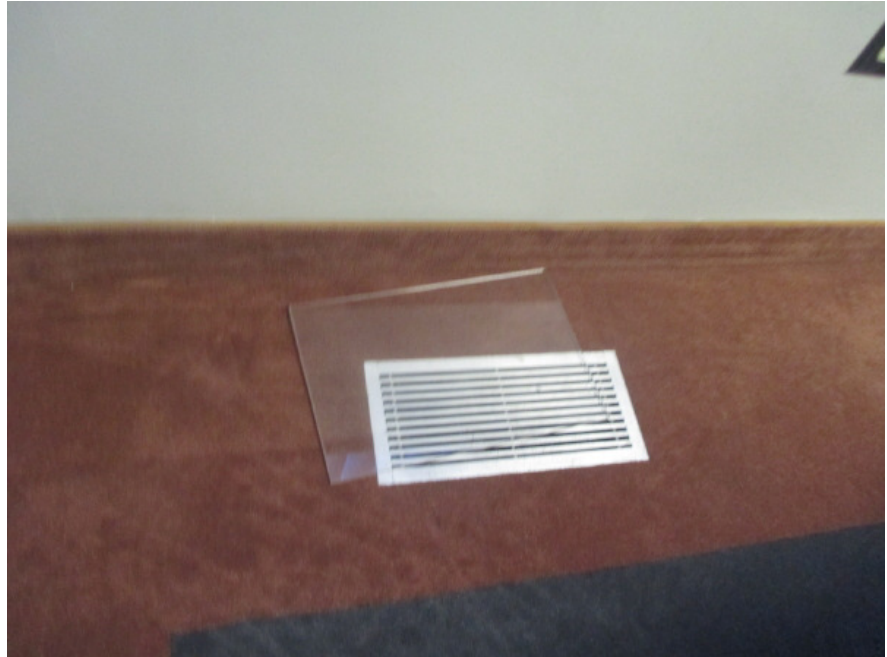
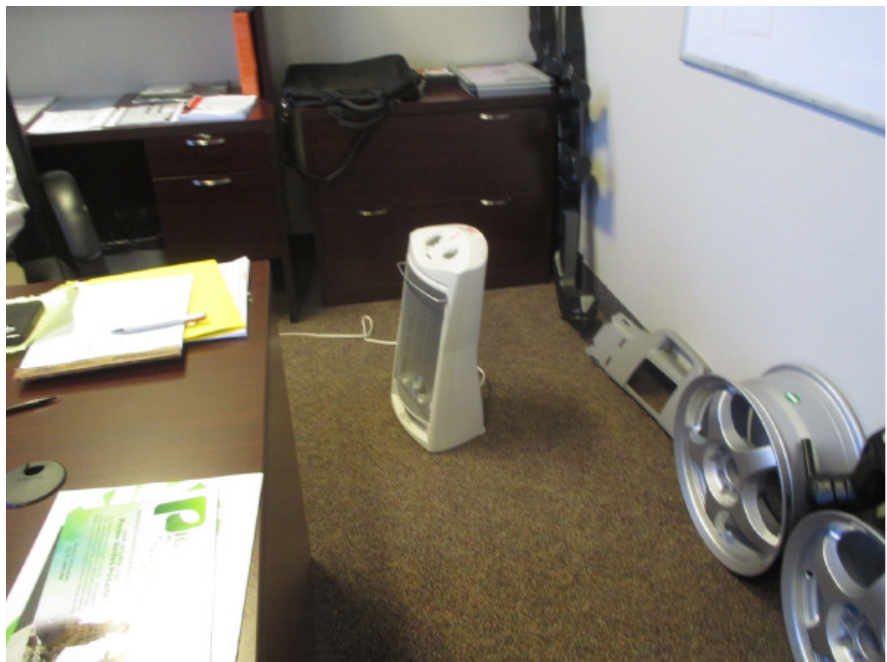
- HVAC zoning system may not be working properly. The large office near the N corner of the 2nd floor was very hot, with pieces of plexiglass observed on and near registers to reduce the heat flow. Tenants complained about rooms sometimes being very cold, and space heaters were observed in many rooms. Servicing is recommended. If the system cannot be corrected, it may be best to simply use manual adjustment of registers for supply flow.

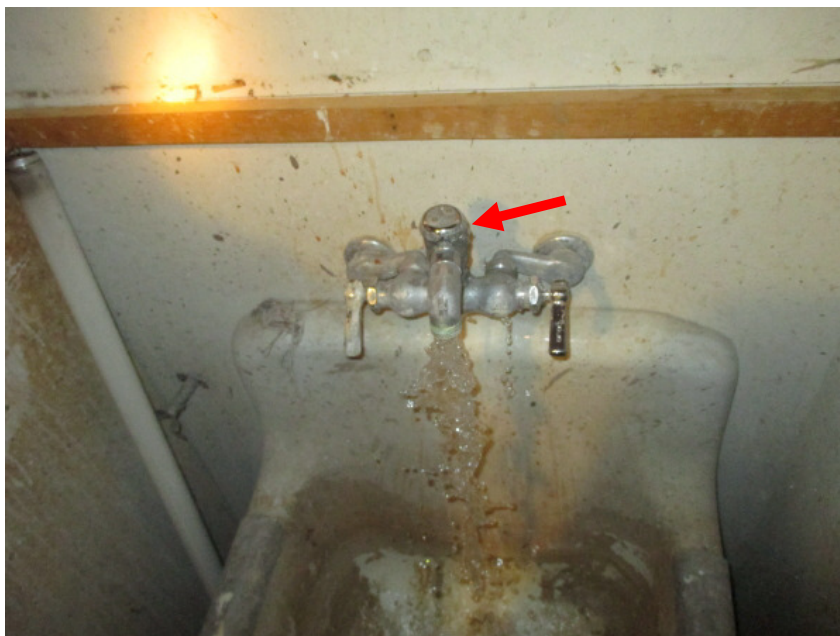
- Noticeable leakage was observed from the faucet for the 1st floor utility room sink, evidently from an anti-backflow mechanism on the faucet. Almost all of the leakage was directed into the sink anyway. The faucet also slightly dripped when it was off, which may be correctable with a new stem washer.

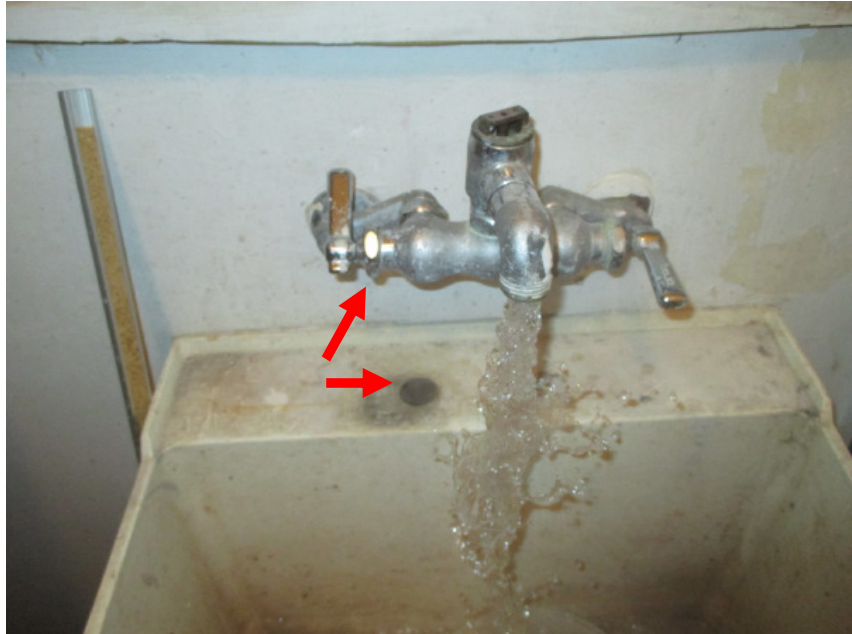
- Stem leakage was observed from the 2nd floor utility sink hot water faucet. Tightening of the stem nut may correct this if it can be done so as not to make the handle too difficult to turn.

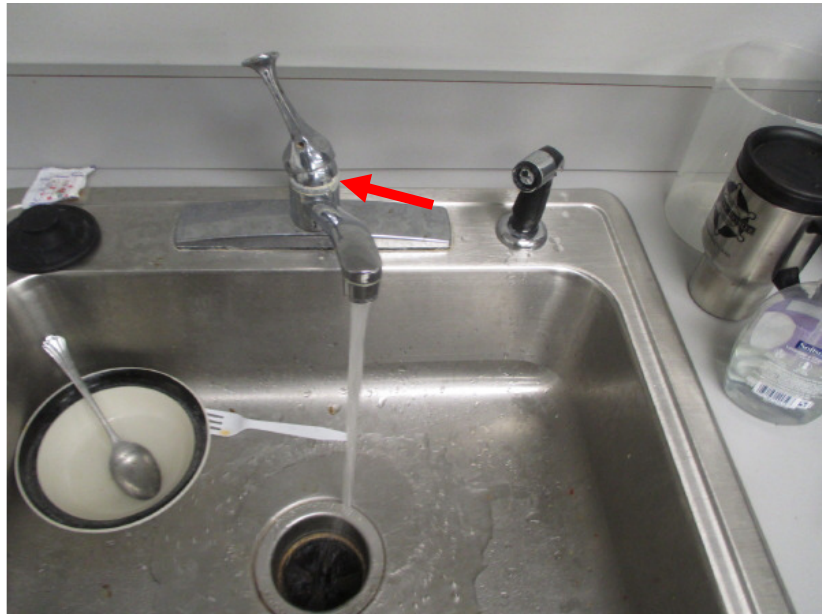
- Very slight, intermittent stem leakage was observed from the 1st floor break room sink faucet.

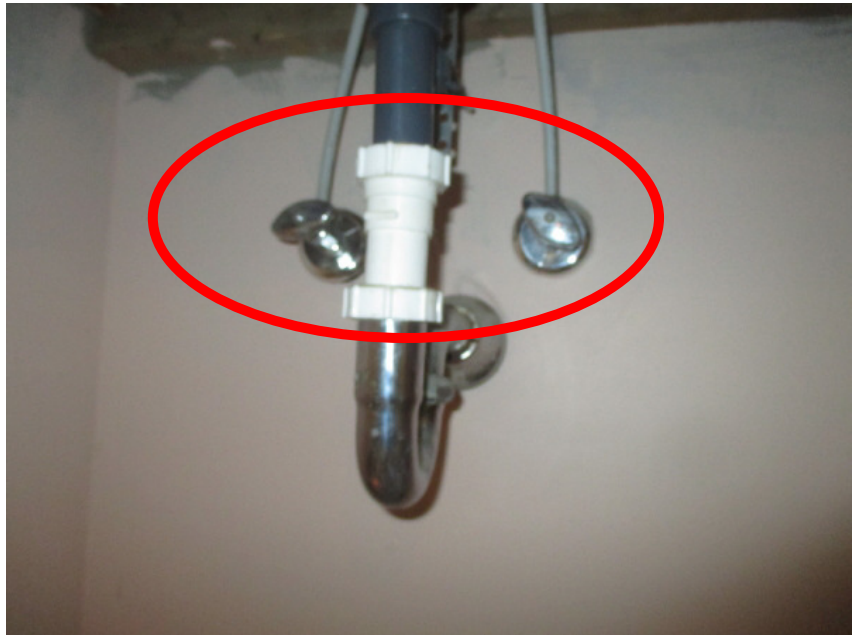
- Most of the shut-off valves ("stops") under sinks were stuck in their open position. A stuck valve may be able to be operated by turning it very carefully with pliers or a wrench. If it still does not operate properly, replacement is recommended.

This was not done during the inspection because sometimes valves leak when forcibly opened after being stuck.

Repair or replacement of any inoperative shutoff valves is advisable so it will be possible to work on fixtures individually without shutting off water elsewhere. It is important to use replacement valves that are compatible with the supply lines and conform to current codes.

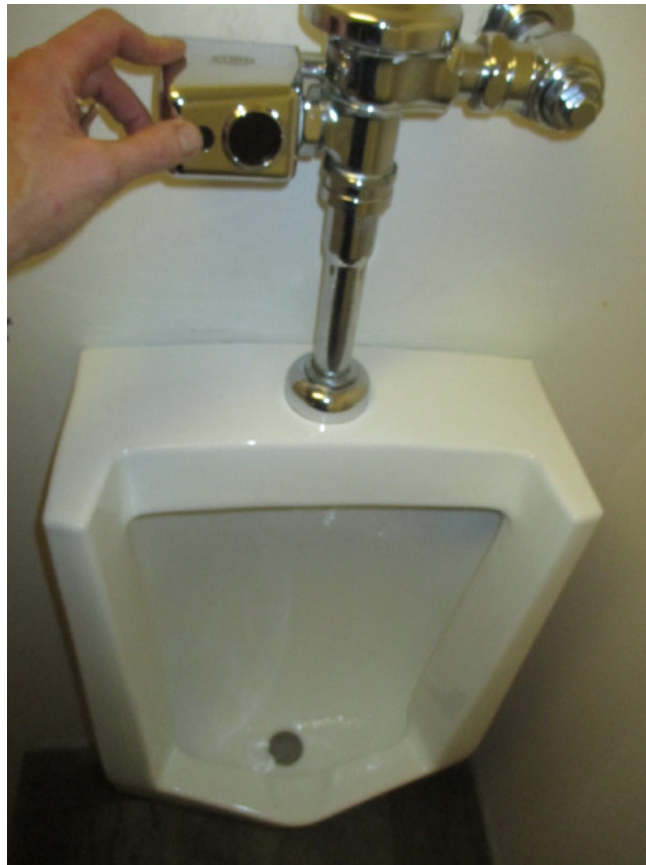
- Automatic flush sensor for the 1st floor men's lavatory urinal did not function. The toilet did flush manually by pushing the button next to the sensor.

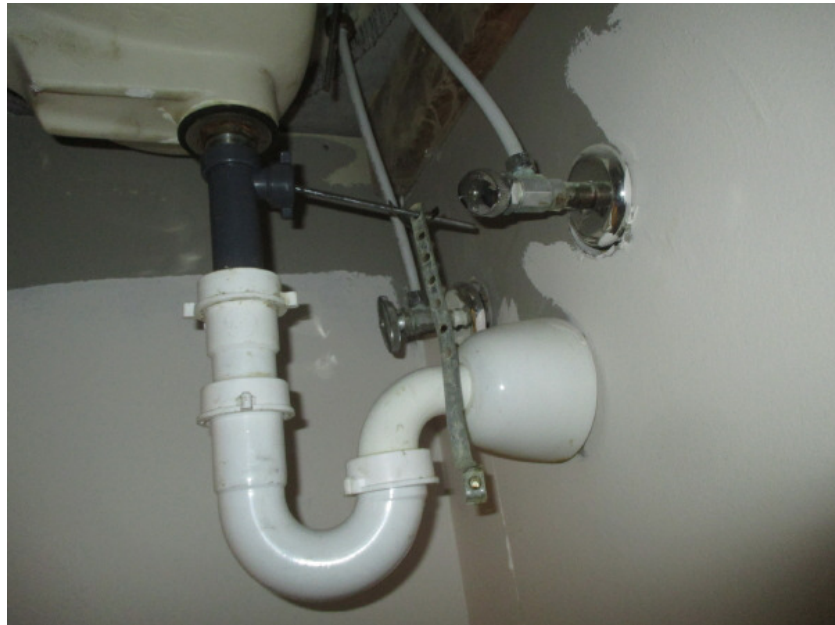
- Stopper was disconnected in one of the 1st floor men's L sink and did not function in one of the 2nd floor women's lavatory sinks. The adjacent sinks had functional stoppers.

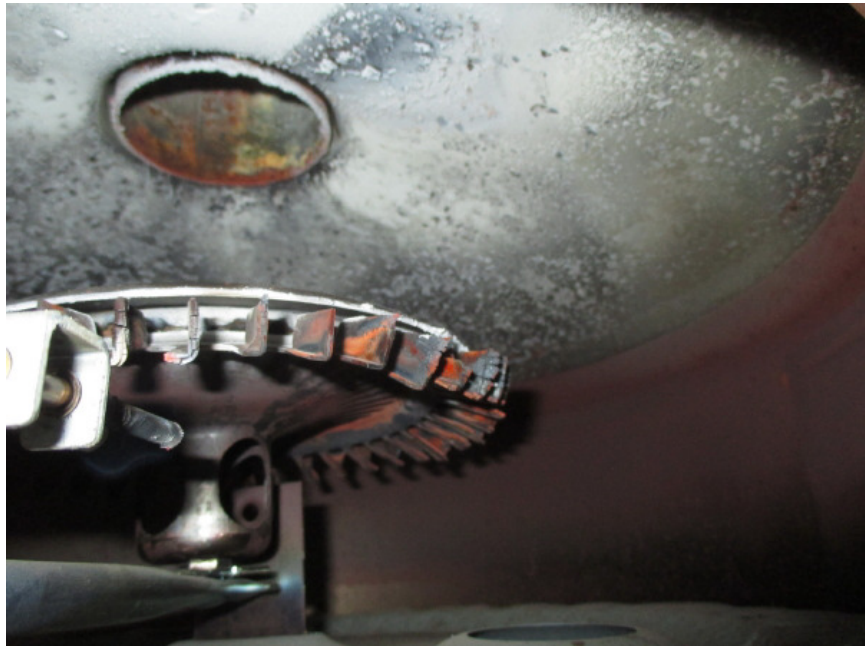
- The bottom of the tank showed relatively little rust for a unit of its age, consistent with a unit that could be operable for many years to come, but a unit of its age could have more serious internal corrosion that was not visible. It is advisable to periodically drain some water from the tank to see if a persistent, rusty color is present and watch for any external indications of tank leakage.

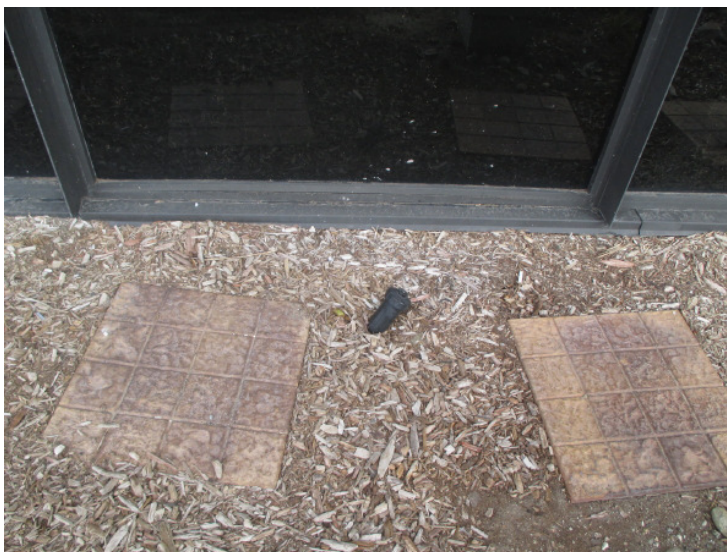
- Sprinkler head near the main parking lot (SW side) entry door was leaning, and as such would probably misdirect its spray.
