PROPERTY INSPECTION REPORT

Concerning: **24175 Sample Ave., Detroit, MI**

Inspection Date: **November 30, 2013**

Construction: **Metal frame office building on a concrete slab foundation**

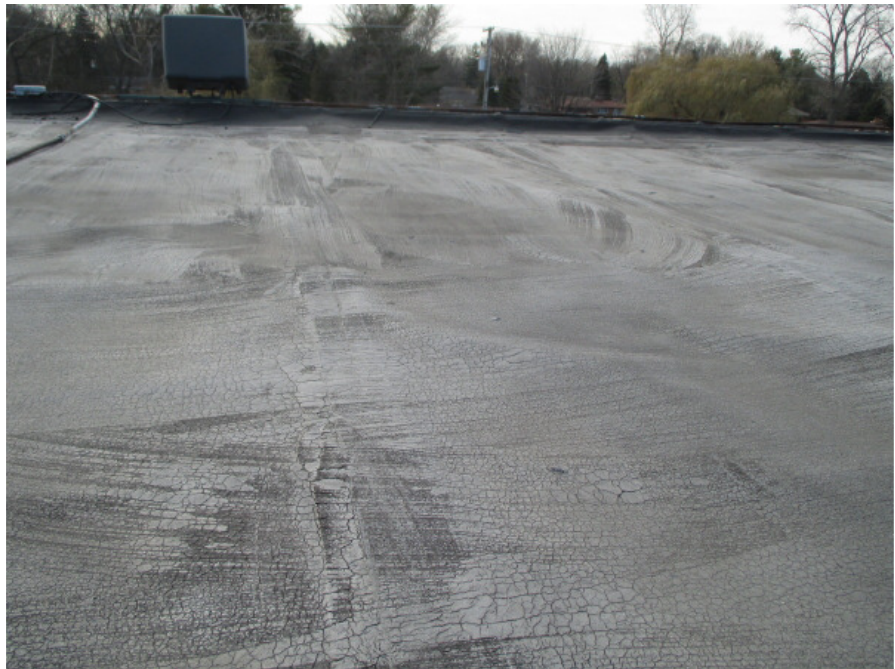
- Tar and felt roofing was observed to be generally in good condition, except as otherwise noted.
- Stacks, vents, and other associated features were observed to be generally in good condition.
